TITLE: HEAT PIPE DEVELOPMENT STATUS

AUTHOR(S): Michael A. Merrigan

SUBMITTED TO First SP-100 Program Integration Meeting
Radisson-Ferncroft Hotel
Danvers, MA
June 13-15, 1984

HEAT PIPE DEVELOPMENT STATUS

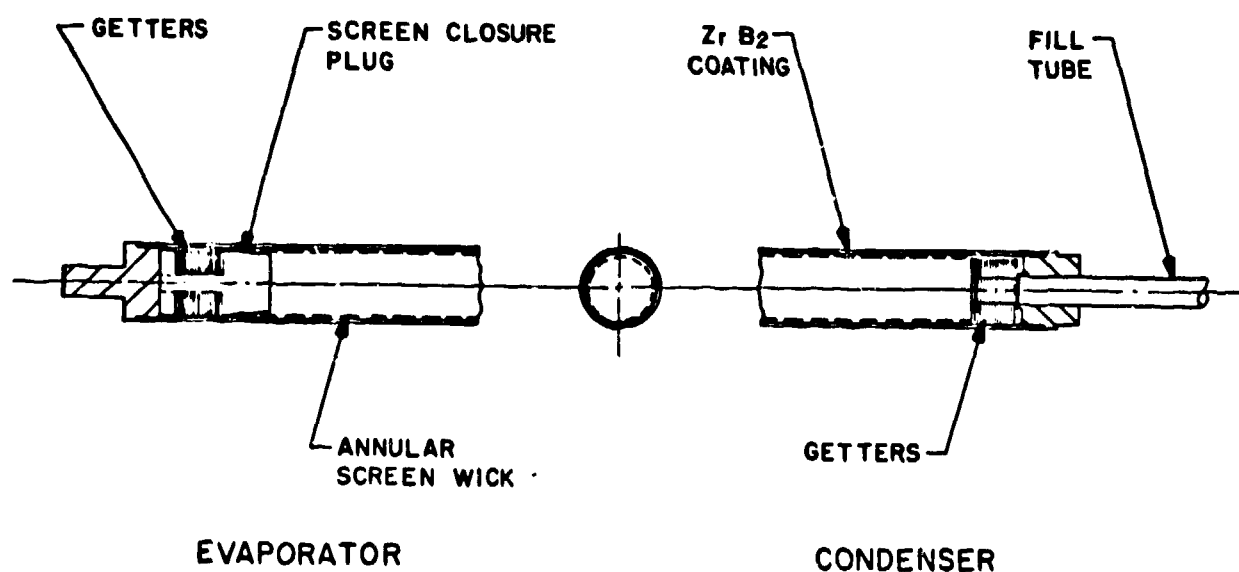
The 2 meter long heat pipe employed an annular wick of 400 mesh molybdenum-rhenium screen and a containment tube of 1.59-cm diameter low carbon molybdenum tubing. Wall thickness of the tubing was 0.8 mm with an annulus space of 0.38 mm and a screen wick thickness of 0.30 mm. Interior vapor space area was 1.26 cm^2 . The evaporator

length of the heat pipe was 40 cm with the remainder of the heat pipe serving as condenser. The condenser region of the heat pipe was coated with zirconium diboride by plasma spray to raise the effective emissivity to 0.61 for the radiation loaded test. The resultant axial power level at 1500 K was 14 kW. A cross section of the heat pipe is shown in Figure 2. Power input to the heat pipe was provided by RF induction at approximately 400 khz, and a water cooled coaxial calorimeter served as the heat sink for radiation from the condenser as indicated in Figure 3. Power throughout was determined from water flow and temperature change measurements at the calorimeter. Heat pipe

Fig. 2. Cross section of extended operation test heat pipe.

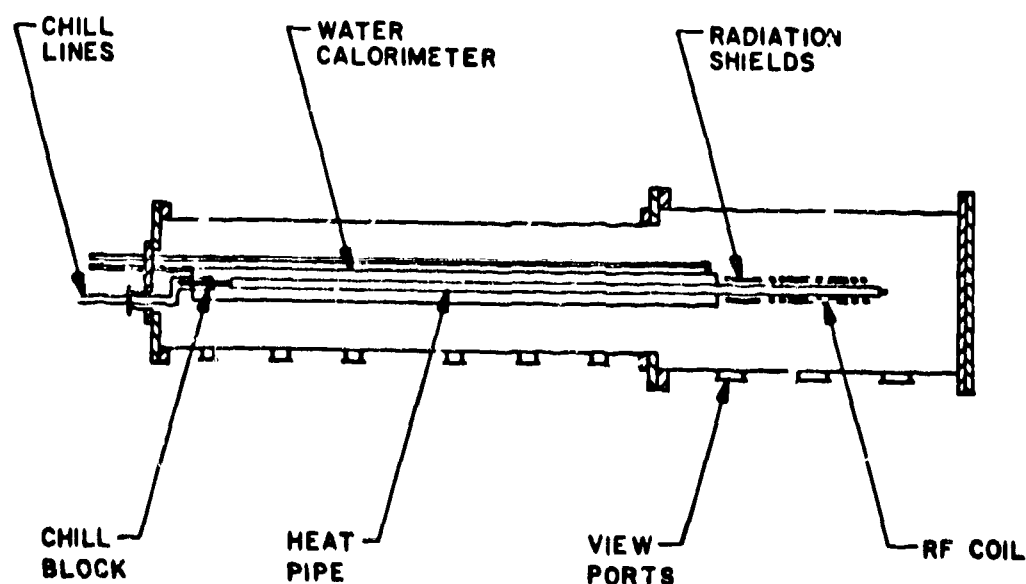
Fig. 3. Heat pipe test set-up.

temperature was measured by tungsten-rhenium thermocouples welded to the heat pipe in the evaporator exit area. The test was conducted in a vacuum chamber maintained at a pressure level of 10^{-6} torr throughout the test.
